Manhole Inspection Summary

Manhole # S07MM1011MH

Location Address: **3500 W GARRISON AVE**

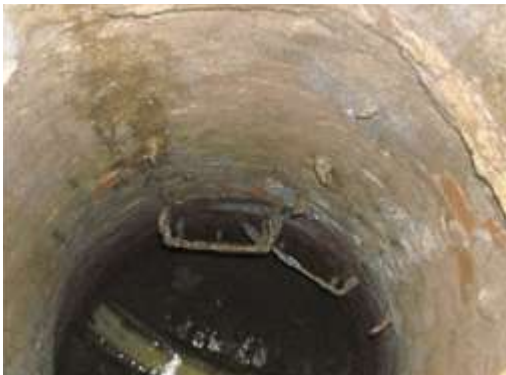
Defect 2

Count: **2** Missing: **6** ☒ **Corroded**

MISSING STEPS

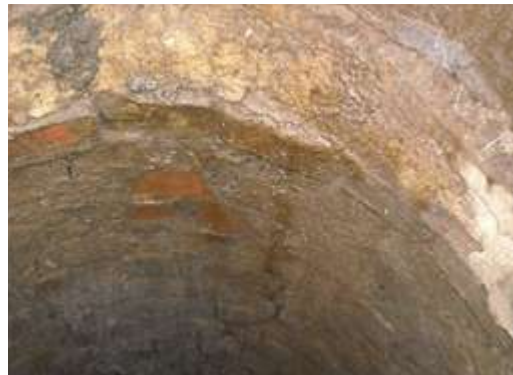
Defect 1

Infiltration: ☐ None ☒ **Joint** ☐ Cracks ☐ Mortar ☐ Roots ☐ Wall

CHIMNEY INFILTRATION

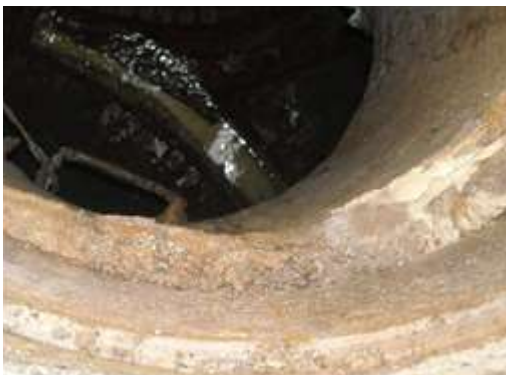
Defect 4

Offset: **2** (in.)

FRAME OFFSET

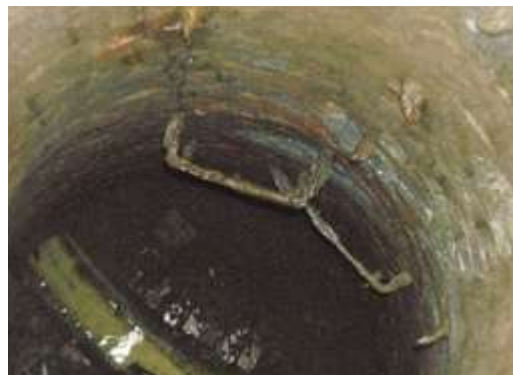
Defect 3

CORRODED STEPS

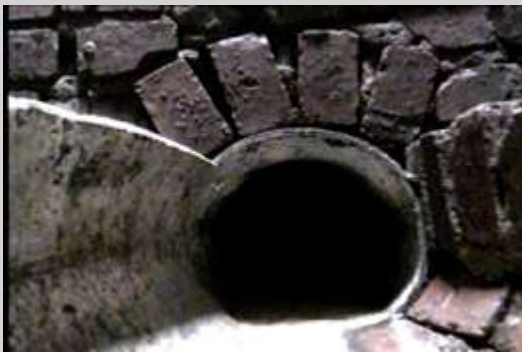
12 O'Clock Outflow

8 in. Circular Gravity Sewer
Pipe Out @ 12 O'Clock

Infiltration: **None** Pipe Seal Cond: **Sound**

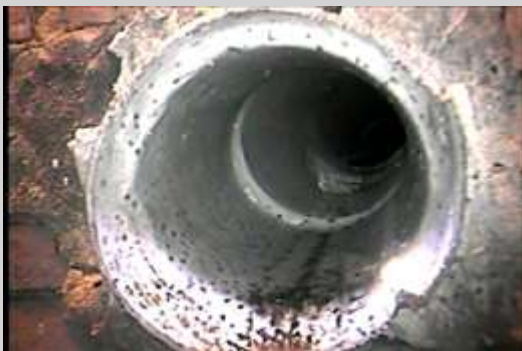
4 O'Clock Inflow

8 in. Circular Gravity Sewer
Pipe In @ 4 O'Clock

Infiltration: **None** Pipe Seal Cond: **Sound**

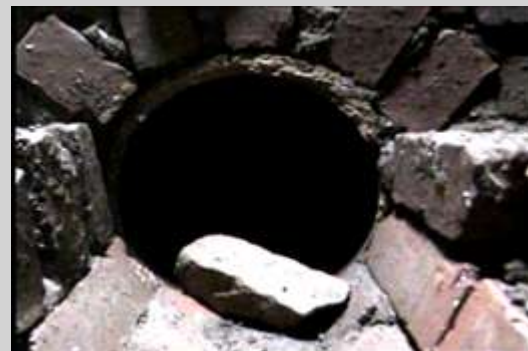
Drop In @ 4 O'Clock

Drop: **Outside** Rod and Bar

Drop Condition: **Open**

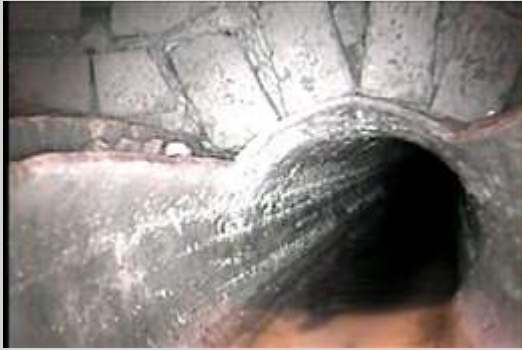
8 O'Clock Inflow

8 in. Circular Gravity Sewer
Pipe In @ 8 O'Clock

Infiltration: **None** Pipe Seal Cond: **Sound**
